DEFECTS IN HARDWOOD VENEER LOGS: Their Frequency and Importance

E. S. Harrar

SOUTHEASTERN FOREST
EXPERIMENT STATION
Asheville, North Carolina

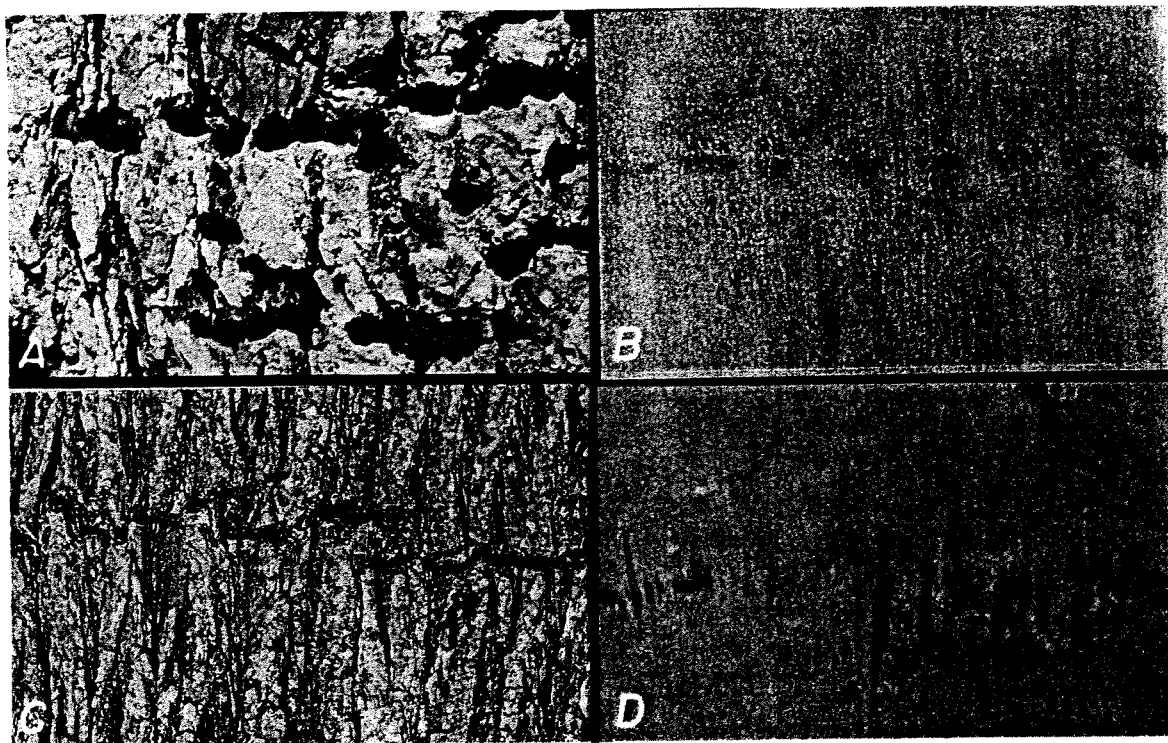
Figure 1.--Bird peck. A and B, Fresh bird-peck damage in yellow-poplar. C and D, Old bird-peck activity in sweetgum as indicated by transverse checks in the bark and stain blemish in the veneer.

Peck holes of recent origin are characteristically dry and open, but those which were made many years ago are usually closed with plugs of callus or traumatic tissue.

In contrast, sapsucker activity in sweetgum often results in serious damage to potential veneer logs. Since the bark of this species is comparatively thin, the birds in making fresh tap holes commonly drill across the cambium into the outer periphery of the woody cylinder. Excavations such as these provide a readily accessible entrance into the wood for stains (fig. 2), and wood-destroying fungi. Localized regions in logs and blocks contaminated in this manner provide very little quality veneer. Old wounds on sweetgum will eventually disappear, but transverse bark checks usually indicate deep sapsucker wounds.

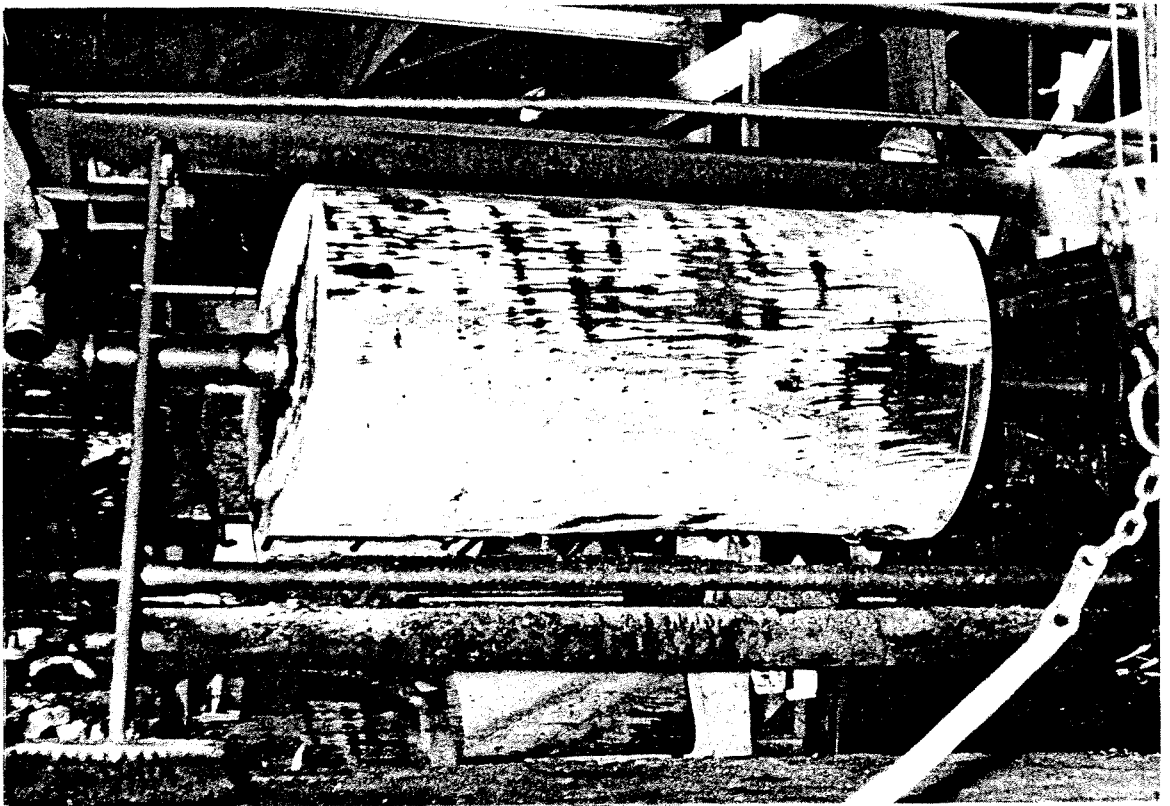
Figure 2.--Areas of discoloration in sweetgum caused by bird peck.

callus tissue or included bark, and practically all of them are the focal points of unsightly stains and streaks of decay. The initial attack may have been made many years before the log was harvested, but the defects continued to develop as new wood was laid down on the cylinder and very frequently may be observed by merely removing the bark.

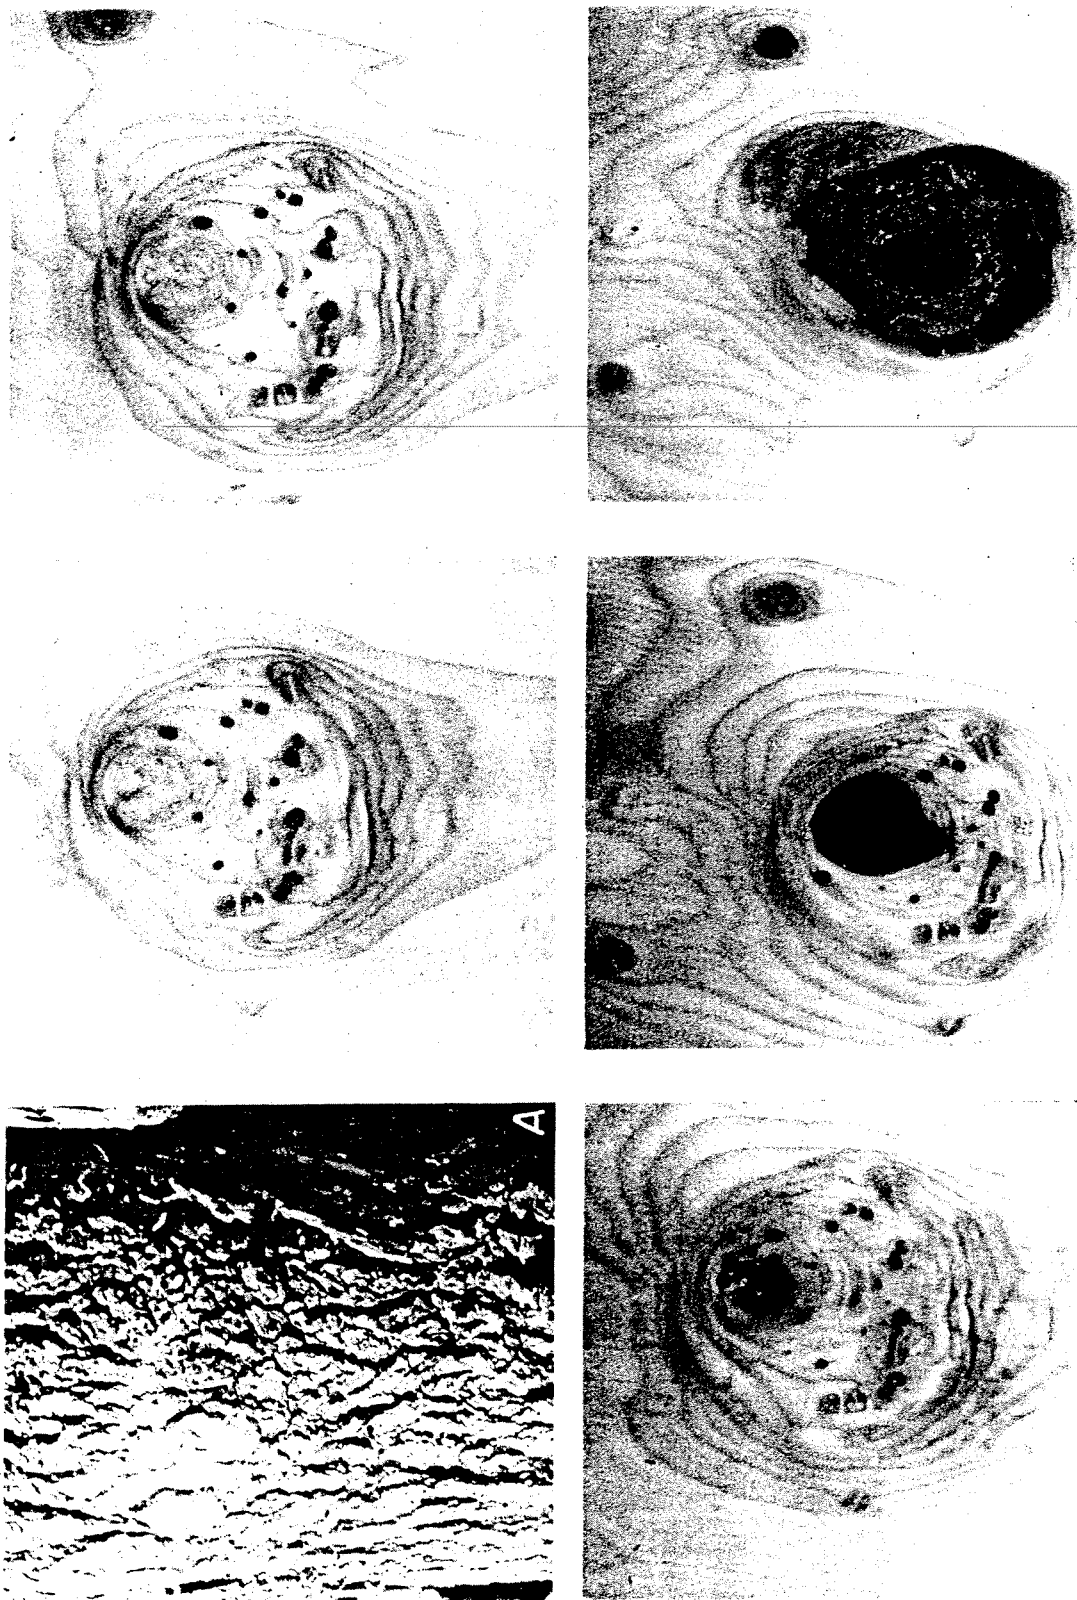
In general, clusters of adventitious buds on yellow-poplar and sweetgum logs not only in themselves produce blemishes in sheets of rotary-cut veneer, but also signal the presence of larger and far more serious defects below.

Figure 3.--Adventitious buds. A, Bark pattern in yellow-poplar above a cluster of adventitious buds. B, C, D, E, F, Pattern in veneer at 2-inch intervals across the radius of the block following rounding of veneer bolt to core.

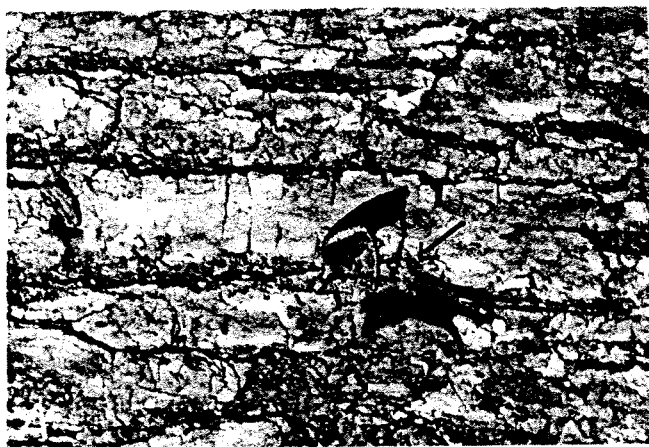
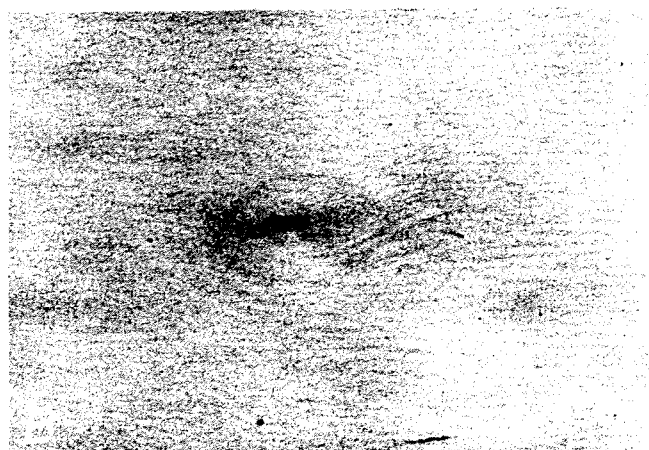
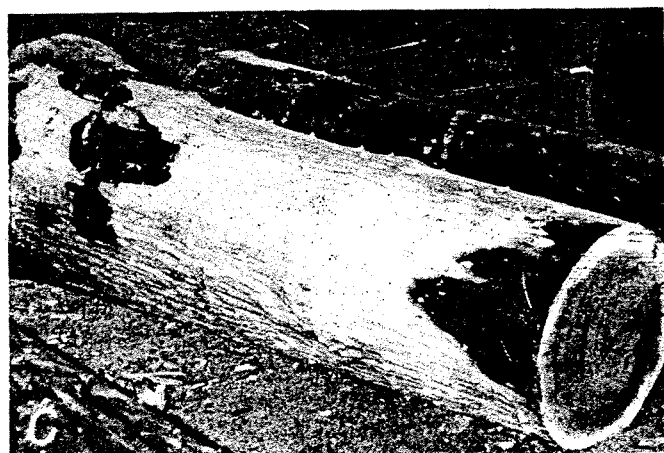
In rotary-cut veneers, these radially aligned tissue bundles appear on the face of sheets of veneer as minute pin knots. These are not of sufficient magnitude to affect sheet quality adversely except in face stocks, and then only when their frequency is greater than two per square foot of surface area.

Figure 4.--Dormant buds. A, Dormant bud sprouting on sweetgum log. B, Pin knot in veneer traceable to dormant bud. C, Traces of dormant buds on peeled tupelo log.

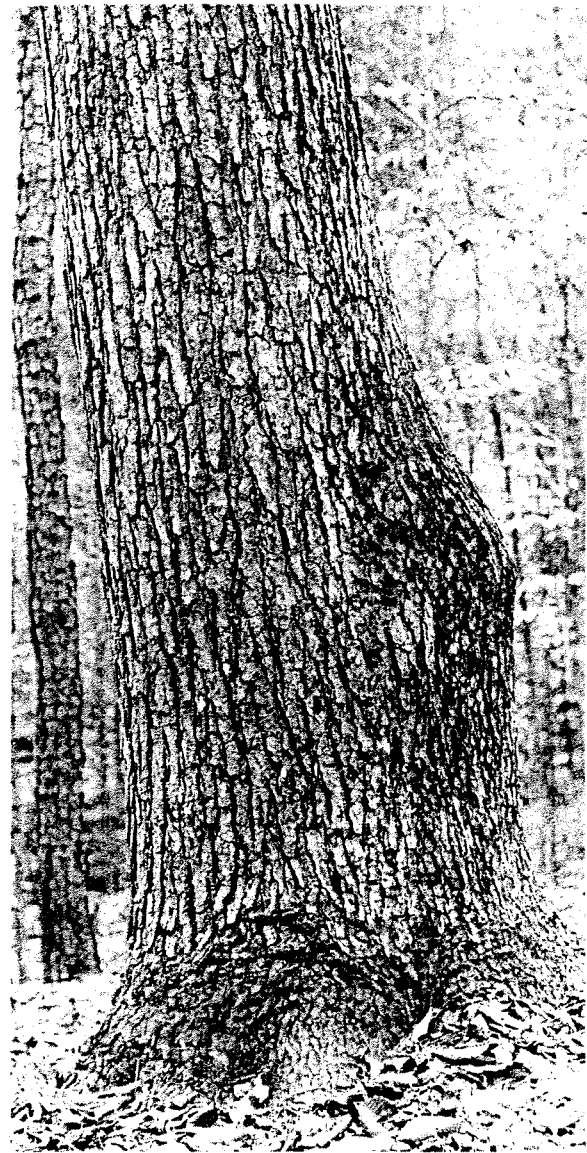
Lockard et al.^{3/} describe bulges as abrupt barreling effects at the base of trees or upward at any level along their boles, and point out that these malformations are indicative of advanced stages of heartwood decay. A butt bulge usually signifies a hollow core with varying amounts of decay above the swelling. Stem bulges, although seldom hollow, signify localized heart rot, and hence are also a region of cull. Blocks or logs featuring butt or stem bulges contain volumes of merchantable wood in the outer regions of the cylinder, but since it is impossible to chuck material of this sort firmly in a lathe, such logs are ordinarily considered worthless for the production of rotary-cut veneer. Trees with prominent butt bulges are either jump-buttied at the time of felling or left standing; stem bulges are commonly removed from felled timber as a part of the logging operation.

Figure 5.--Butt bulge in sweetgum.

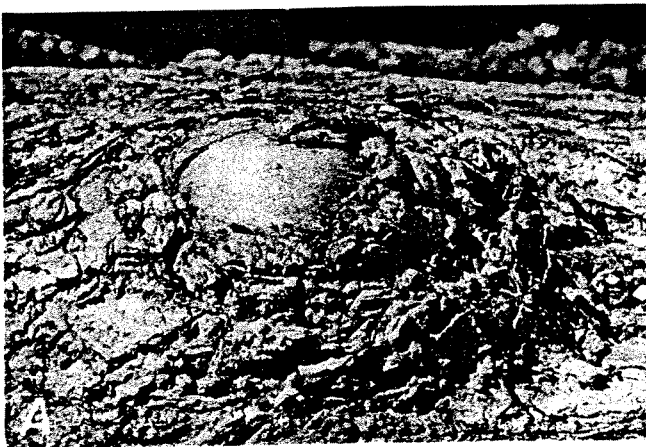
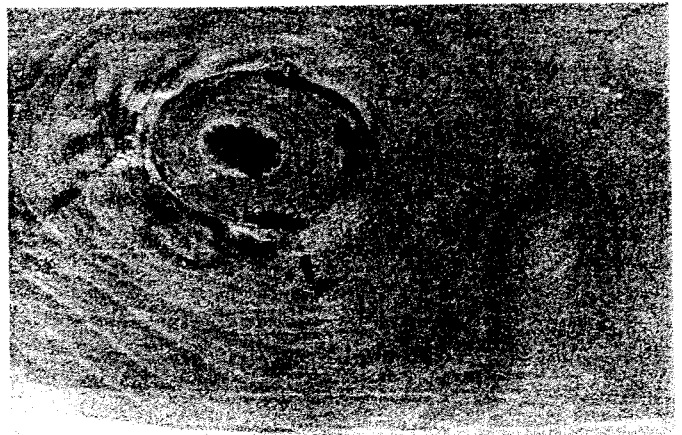
High bumps.--High bumps (fig. 6) may appear at any point along a log, and as a rule foretell the presence of sound or rotten projecting limb stubs and knots, well developed clusters of adventitious buds, localized splits or seams, or ingrown bark. Bumps on butt logs and blocks harvested from local woodlots should be carefully scrutinized since they frequently encase nails, spikes, barbed wire, or other pieces of metal which would severely damage knife and pressure bar if undetected (fig. 7).

Figure 6.--High bump on yellow-poplar. A, Bark removed to show layer of wood over branch stub. B, Veneer underlying bump, showing recently buried branch stub and associated decay.

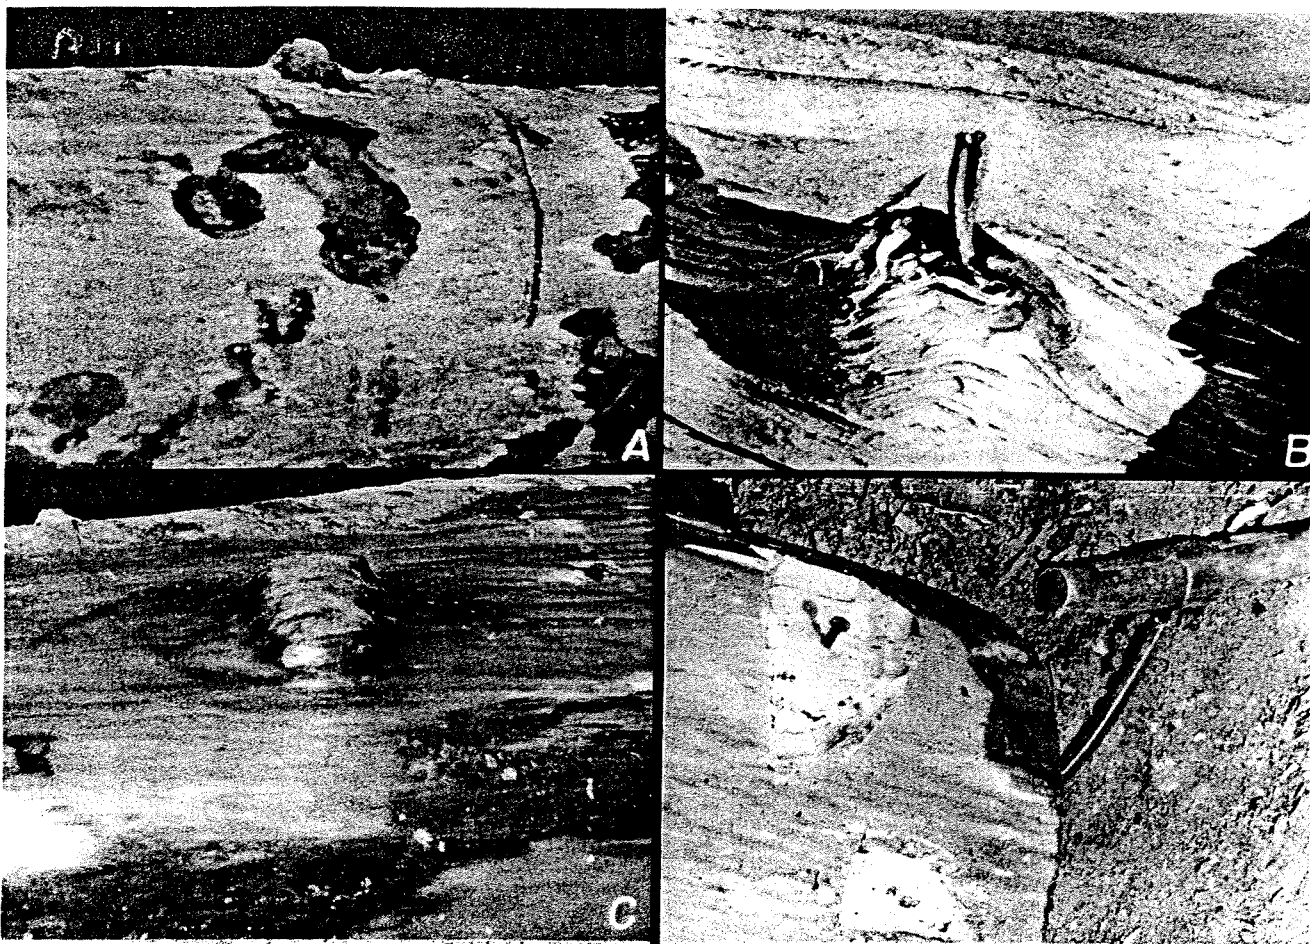
Figure 7.--High bumps. A and B, High bump on basal log of tupelo caused by embedded wire. C and D, High bump on basal sweetgum log caused by spike. Bumps on basal logs should be examined carefully for incased bits of metal.

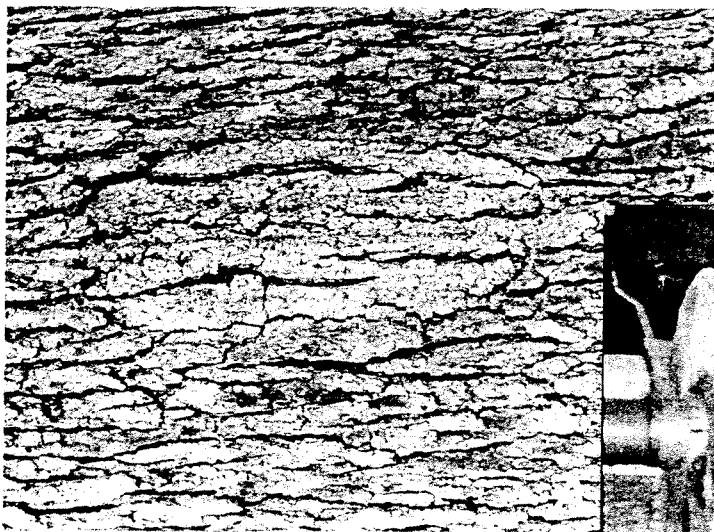
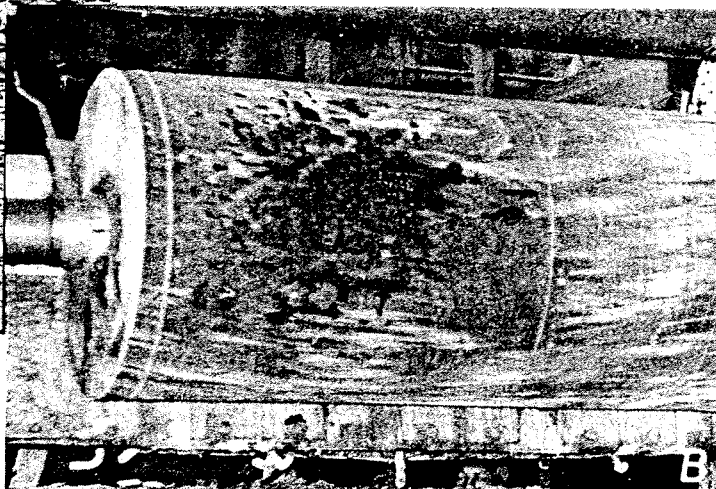
Figure 8.--A, Low bump in sweetgum caused by shotgun pellets. B, Decay developing around embedded lead pellets.

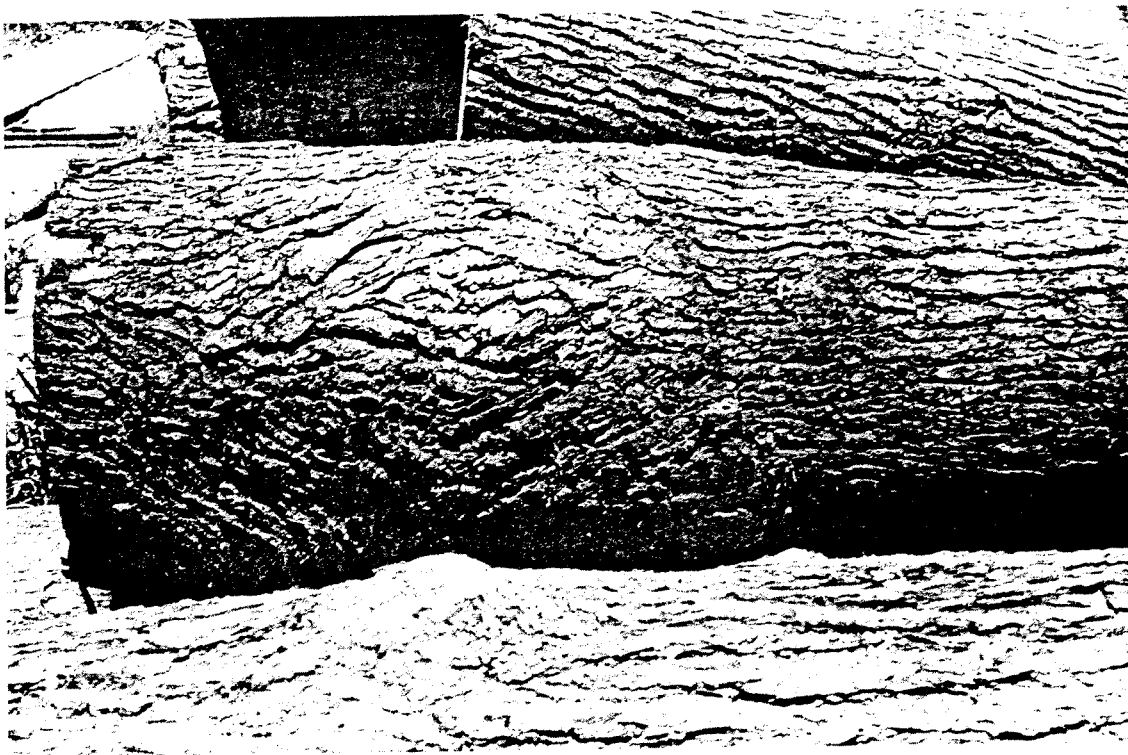
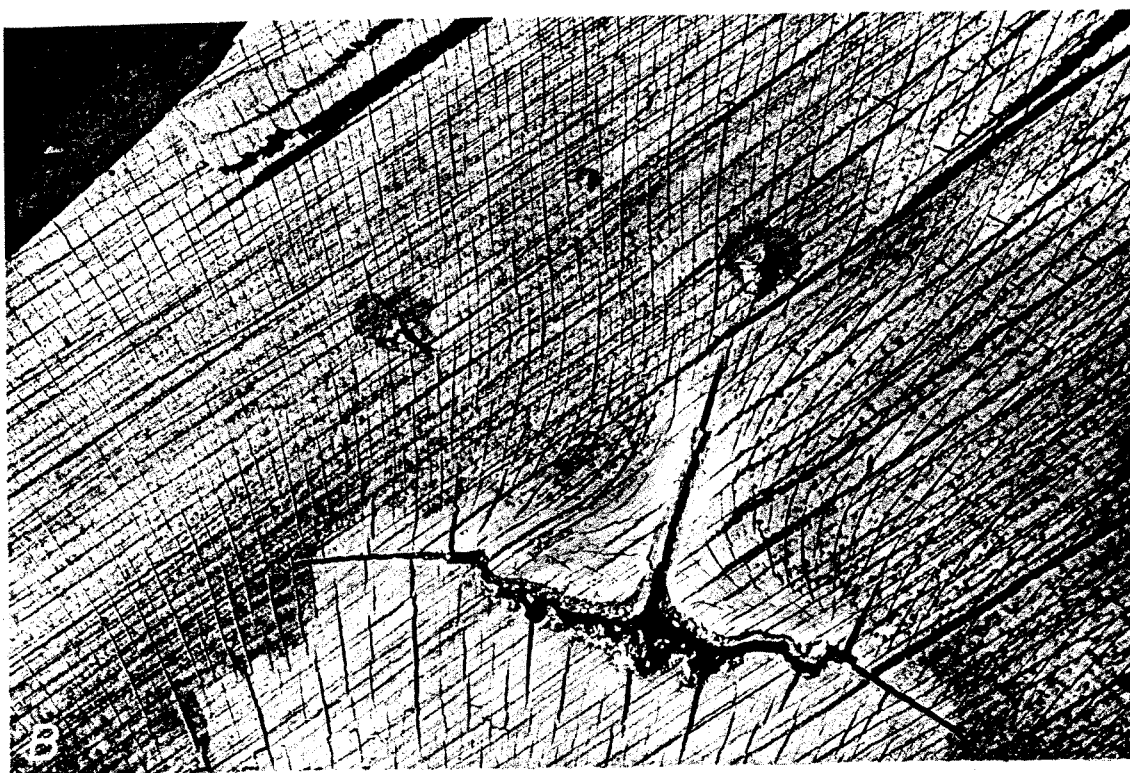
Low bumps.--Low bumps (including surface rises) usually connote the presence of wounds, bark inclusions, localized decay, and in some cases rather deeply recessed branch stubs and knots. Occasionally, low bumps on sweetgum logs indicate the presence of superficial gum cysts. Logs receiving shotgun blasts not infrequently develop low bumps in the vicinity of the wound, with decay developing around the embedded lead pellets (fig. 8). Figure 9 shows a buried seam with included bark under an elongated low bump.

Figure 9.--A, Elongated low bump in sweetgum log 22 inches in diameter. B, Buried seam with included bark under low bump of A.

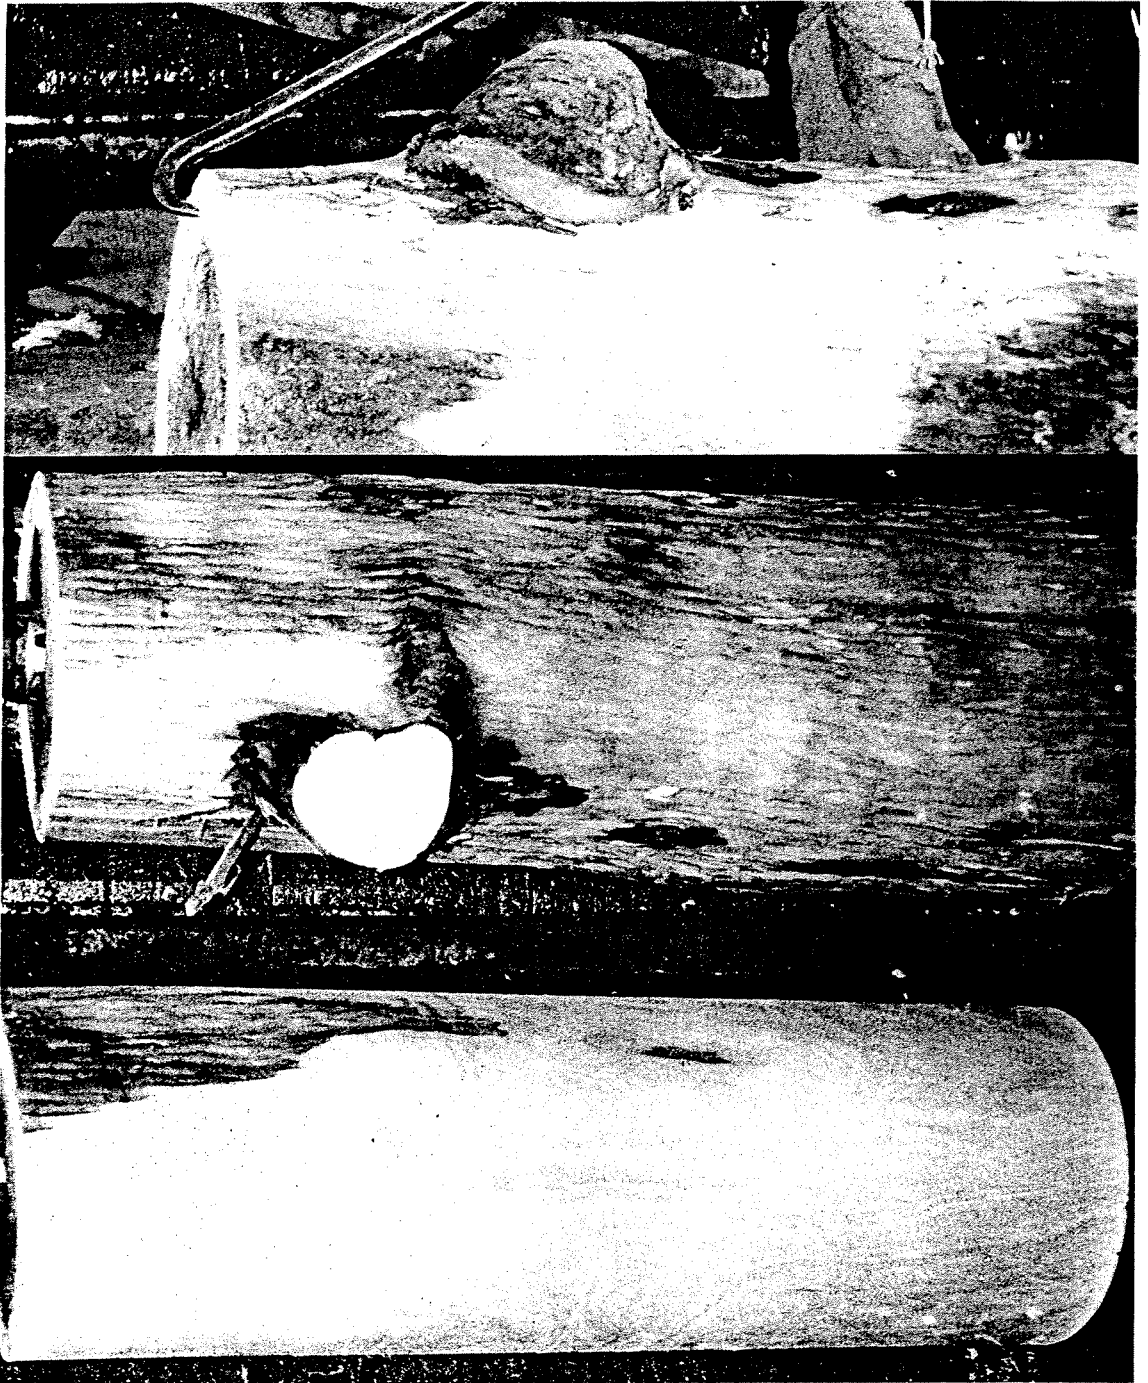
Figure 10.--Burl on tupelo log. Note complete obliteration of burl following rounding, and solid, defect-free wood below.

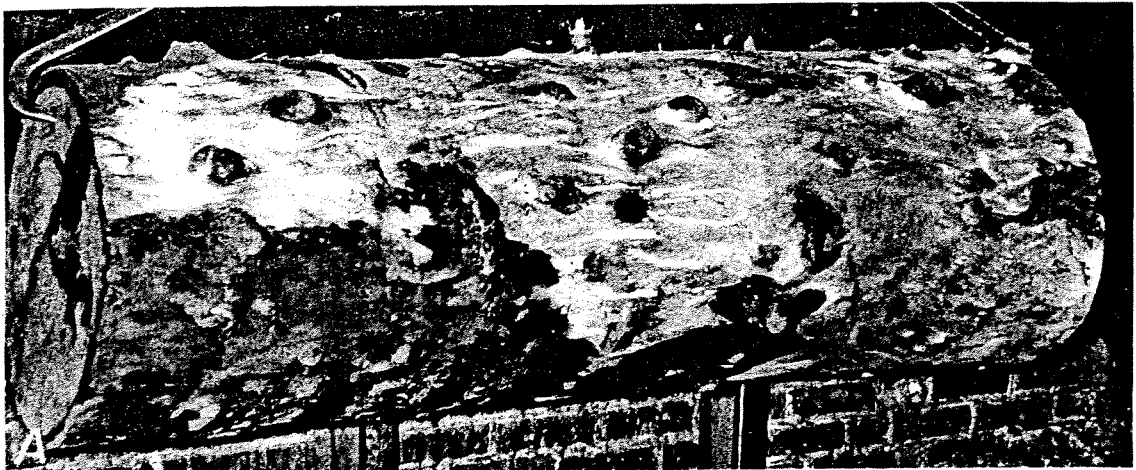
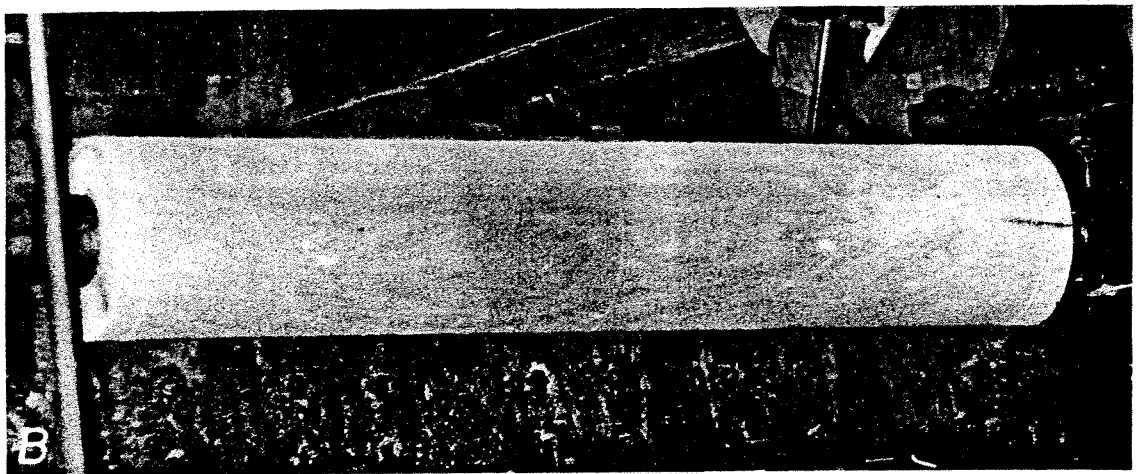
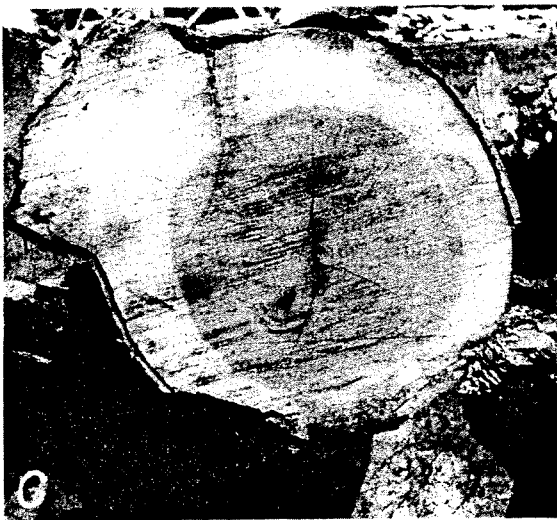
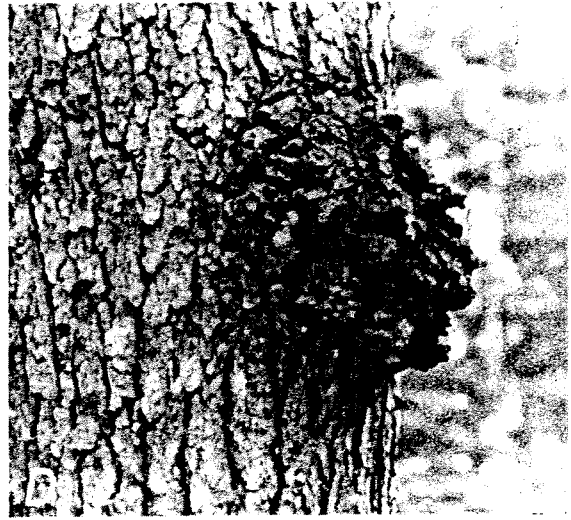
Figure 11.--A and B, Small burls on blackgum log which "washed out" in the rounding. C, Cross-section through a burl on tupelo. Note absence of defect below burl. D, Small burl on a sweetgum log. Burls on the gums are more commonly defective.

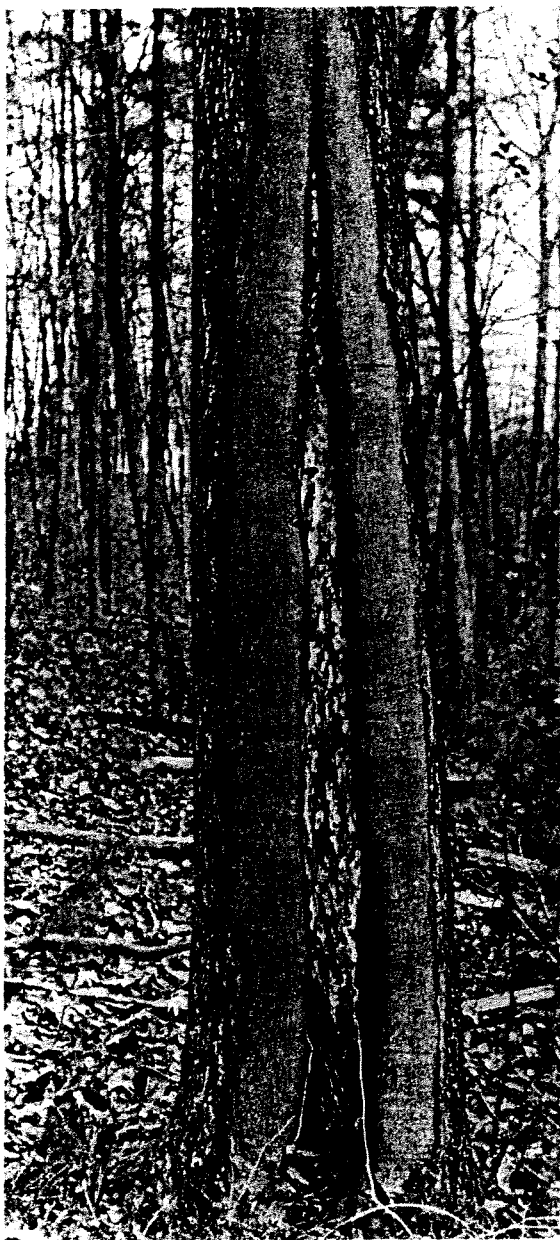
Figure 12.--Butt scar.

that a portion of the woody cylinder is exposed (fig. 12). This injury, known as butt scar, is often traceable to repeated fires or logging damage. Green healthy sapwood laid bare in this manner usually becomes the focal point of insect infestations, stains, and wood-rotting fungi. The wood in old scars is often completely destroyed and hollow butts result, while above the open face of the wound, decay of the heartwood has advanced upward in the bole from a few inches to several feet. Trees with butt scar, like those with butt bulge, are usually jump-budded at the time of felling.

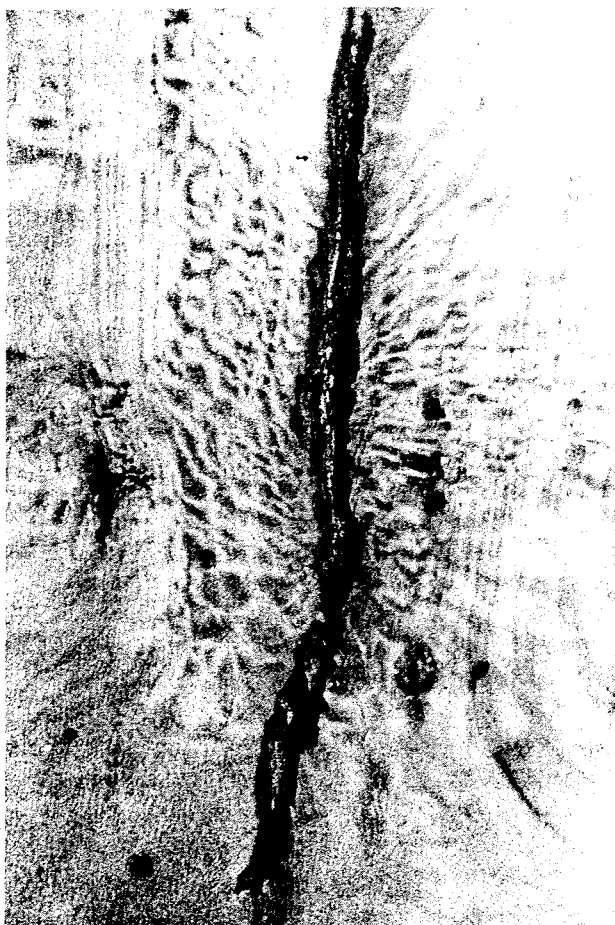
Figure 14.--Included bark between merged flanges in butt cut of sweetgum log.

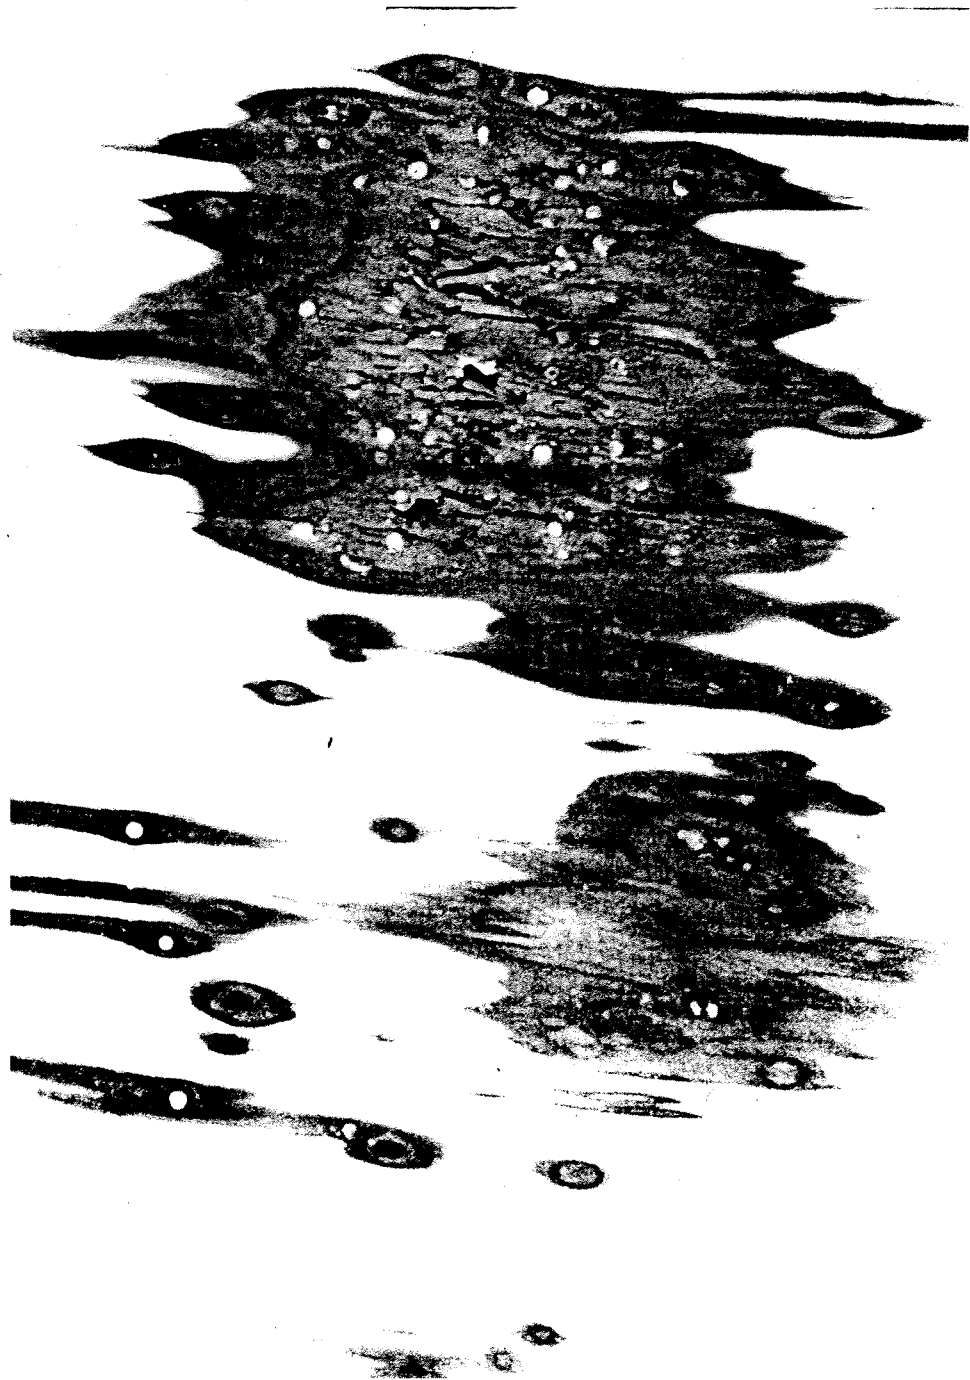
The effect of a full charge of buckshot in the face of a tree is more damaging than that of a single bullet; each hole in the scatter pattern (fig. 15) is a point of entry for wood-destroying fungi, and decay in such regions is often rather general. Holes made by buckshot superficially resemble those of the ambrosia beetles, but upon careful examination it may be observed that many of them do not enter the stem in a radial direction.

Figure 15.---Holes made by shotgun pellets in sweetgum veneer.

Holes traceable to gunshot.--Suspected bullet holes should be probed. Bullets near the surface should be chopped out, those logs in which penetration is extensive should either be carefully worked or discarded. While soft lead bullets rarely impair knife or nose bar on contact, steel bullets will play havoc with these parts of a lathe. Old bullet holes are commonly associated with rot, and thus slugs are often found completely buried in rotten wood.

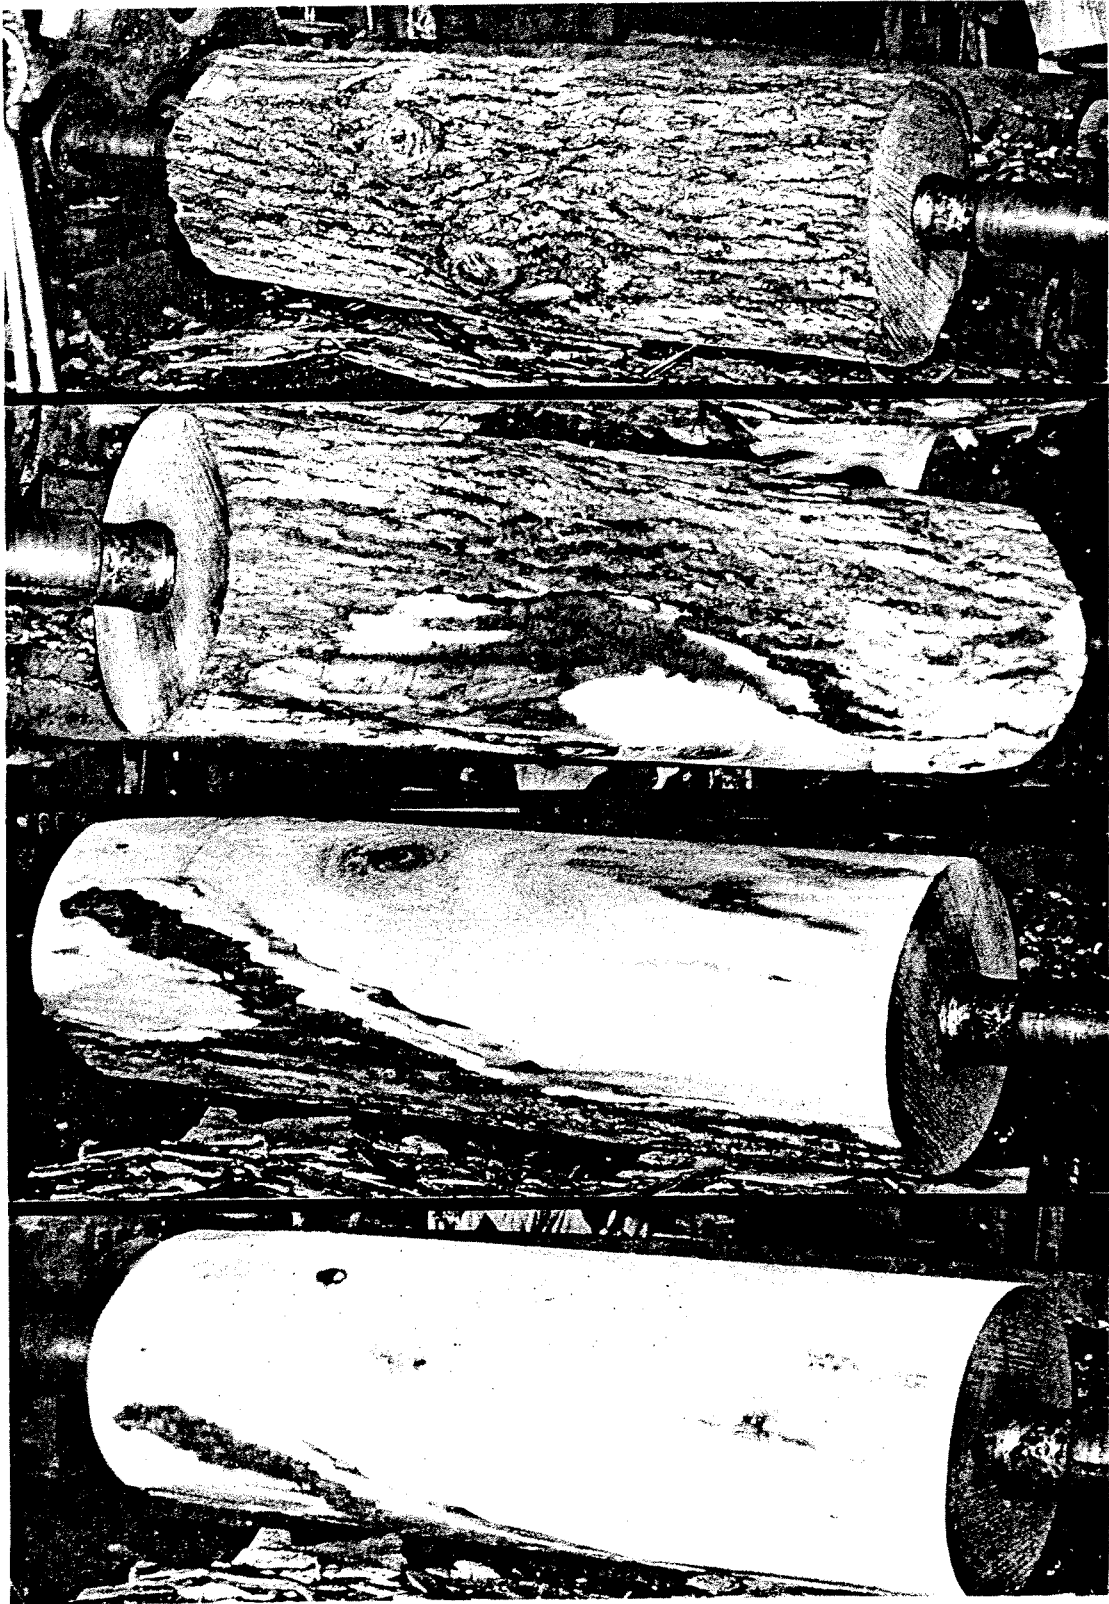
Knots of various kinds are by far the most common and most important defects in hardwood veneer logs. Exposed knots (fig. 17) are common features of small marginal logs and those cut from upper levels of a tree trunk. Butt logs from yellow-poplar, sweetgum, tupelo, and blackgum are exceptionally free from exposed knots, since the lower portions of the trunks of forest-grown trees of these species are usually clean and full-rounded by the time they attain peeler-log size.

Figure 17.--A series of photos tracing knots through a yellow-poplar block from bark to core.

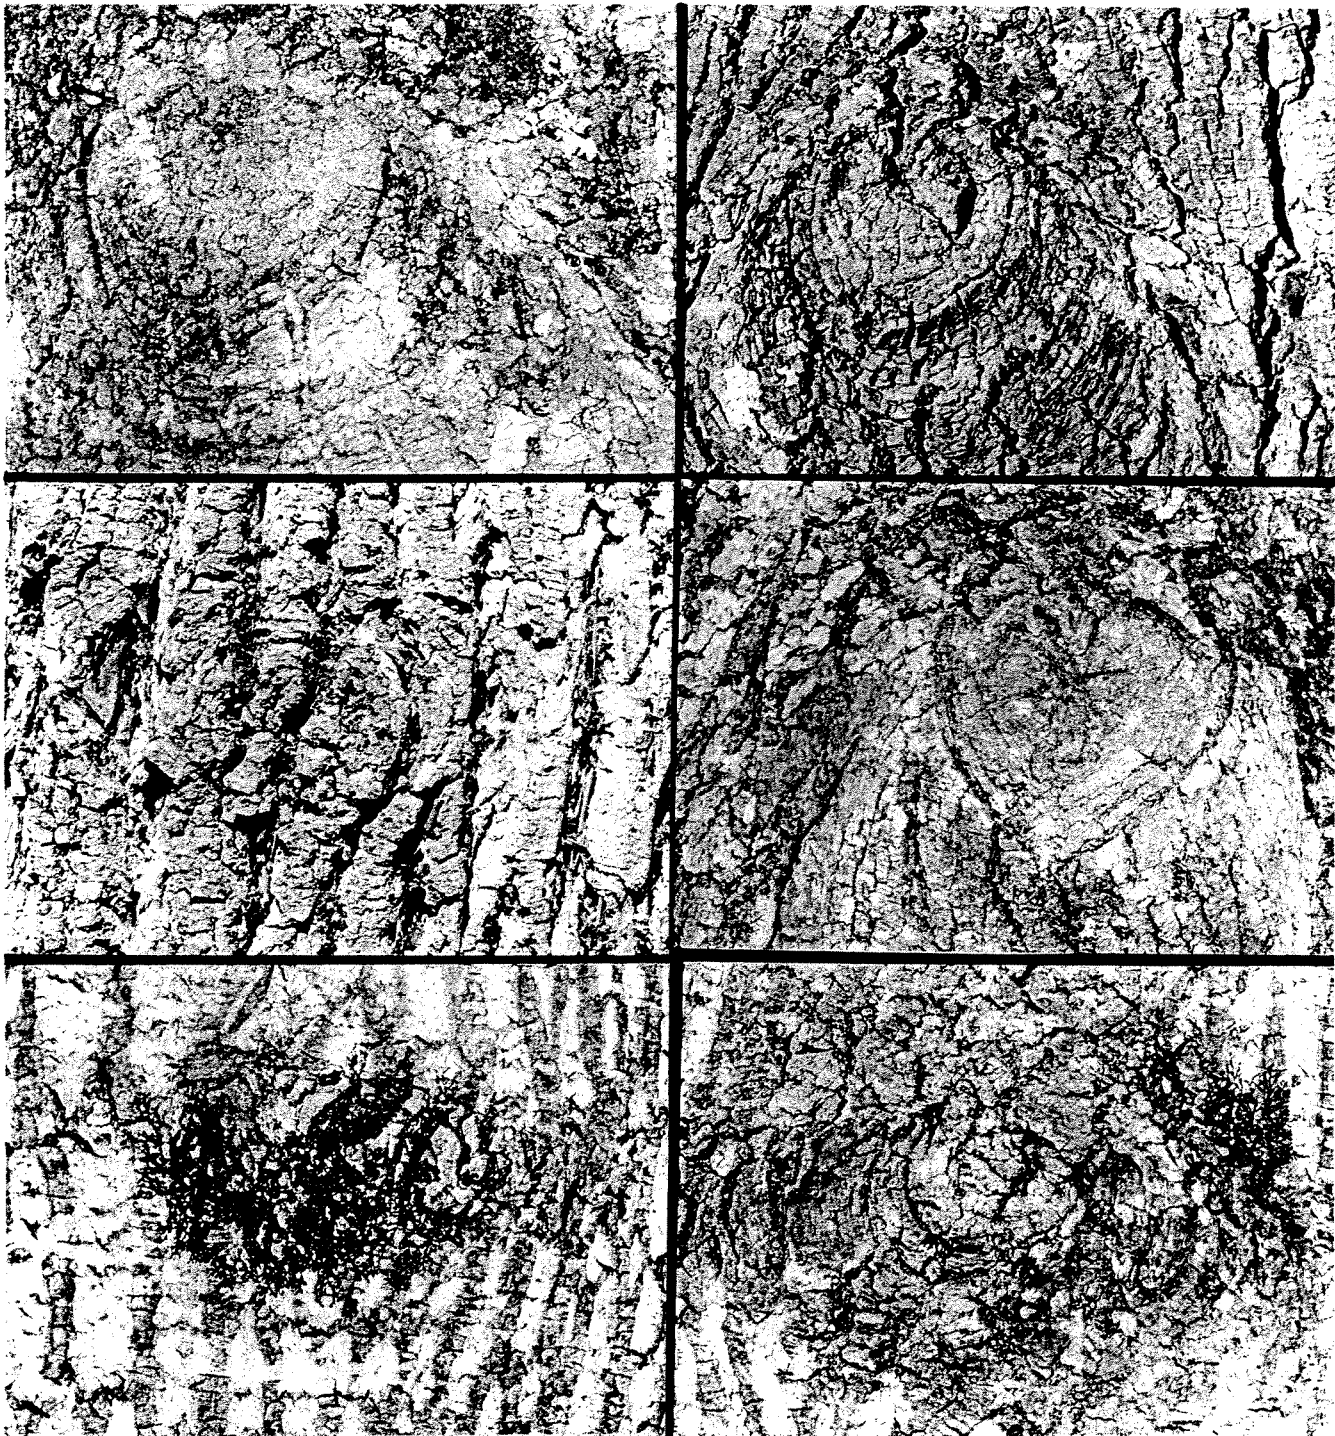
Overgrowths in yellow-poplar.---The most common overgrowths found in yellow-poplar are those associated with knots and clusters of adventitious buds. When a branch stub lies close to the surface of a log, the bark pattern is usually circular in outline and often furnished with a bracket or shelf-like structure on the side nearest to the base of the tree. Those overlying more deeply recessed branch stubs feature cross-seams and angular or curved longitudinal fissures. Figure 18 illustrates a number of overgrowths of this sort, and figure 19 shows the nature of the veneer under one of them.

Figure 18.--Overgrowths in yellow-poplar.

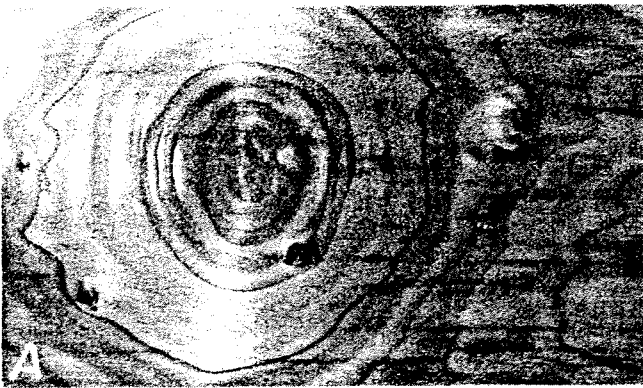
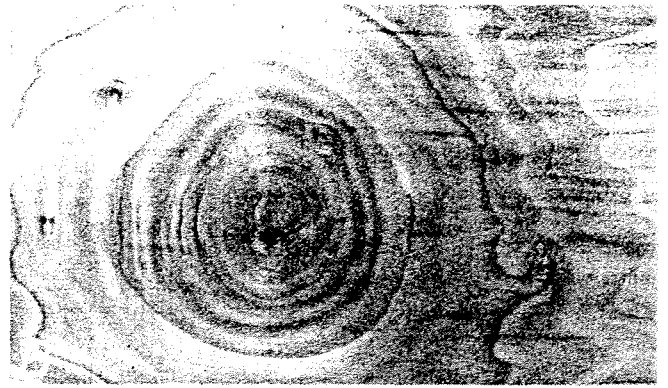
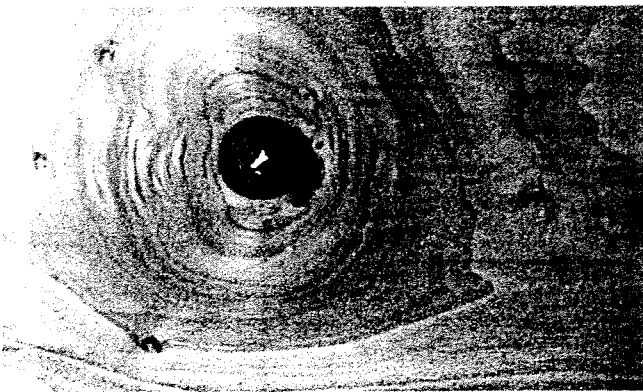
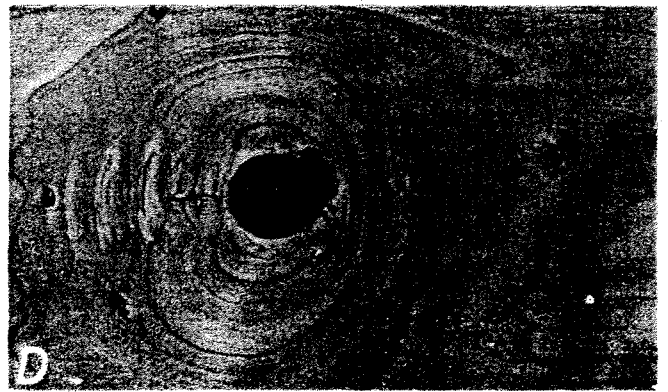
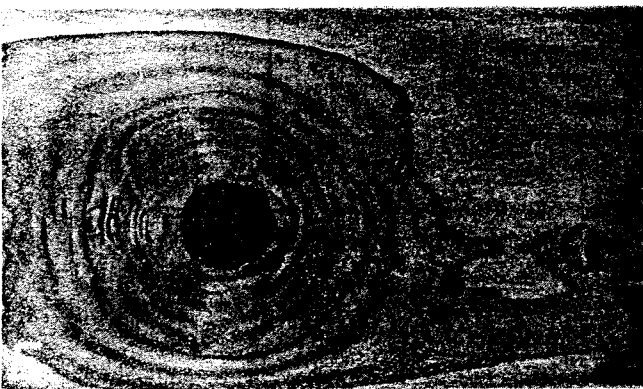
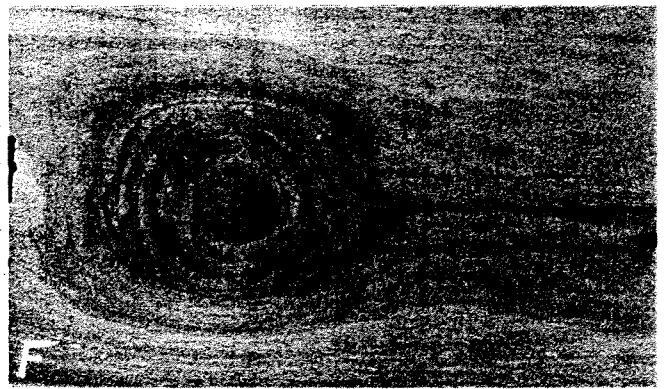
Figure 19.--Veneer under an overgrowth at approximately 2-inch intervals along the radius of a yellow-poplar block.
